# OPERATION PLUMB BOB

NEVADA TEST SITE  
MAY-OCTOBER 1957

Project 30.2

RESPONSE OF DUAL-PURPOSE  
REINFORCED-CONCRETE MASS SHELTER

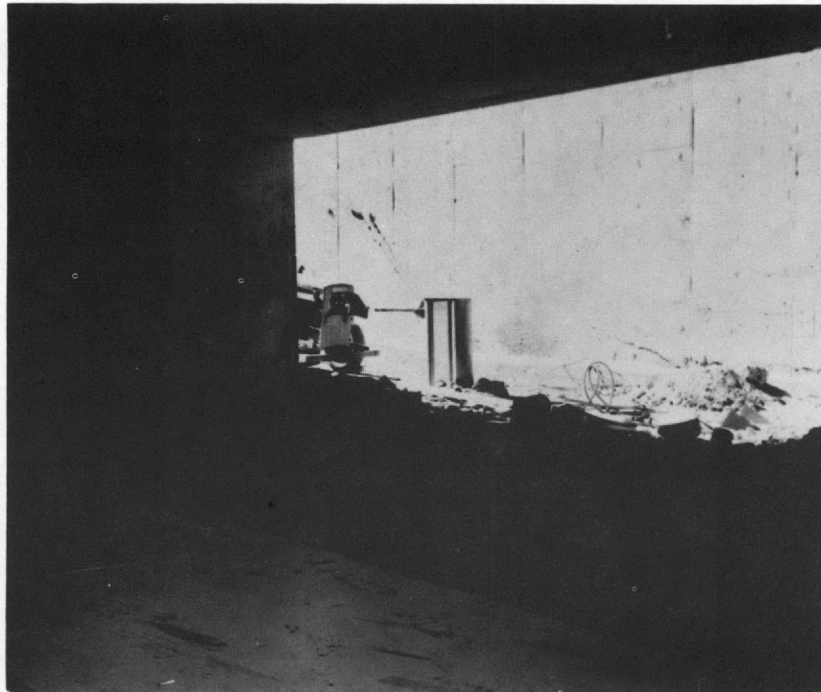
The exposed wall of the garage withstood the blast with no damage. The ramp wall at column line F had several large cracks between the end wall and a point about 30 ft up the ramp (Fig. 3.1). The top of the ramp side wall opposite the door entrance was pushed into the earth about 1 ft at the end. The top edge of the ramp wall farther up the ramp showed little

Fig. 3.1—Cracks in ramp side wall opposite door. View from interior of garage through door opening (postshot).

the ramp. This less-severe face load, in combination with a positive surcharge load, produced no noticeable damage. Although the side wall of the ramp opposite the garage door was loaded by the backup of pressure, the loading was not as severe as that on the end wall. Therefore the side wall of the ramp was only moderately cracked, although it appears that there may have been some bond failure in the cracked area.

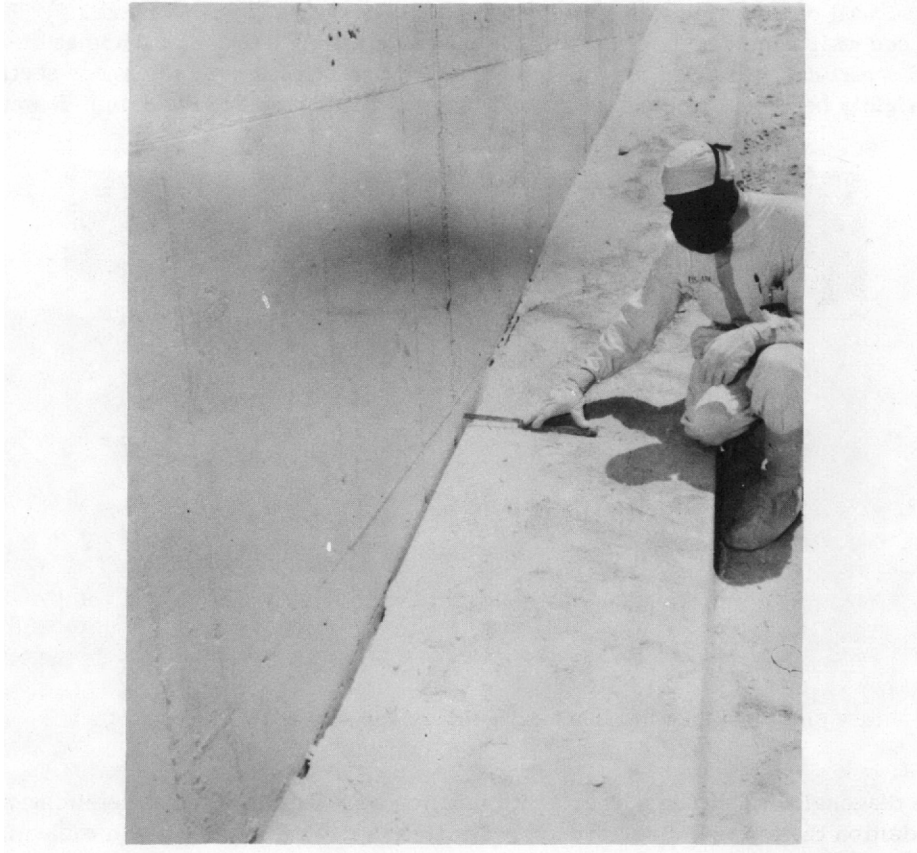
apparent displacement. Although there was no visible damage to the ramp slab, the slab was separated up to  $\frac{1}{2}$  in. from the main garage structure at the expansion joint (Fig. 3.2), and the  $\frac{1}{2}$ -in. joint filler was blown down or out. Gravel backfill was sucked through the weepers onto the ramp (Fig. 3.3). More gravel was found opposite the weepers at the mid-length and toward the top of the ramp than opposite the weepers at the lower end.

Fig. 3.2—Open joint between ramp slab and wall of main garage structure (postshot).

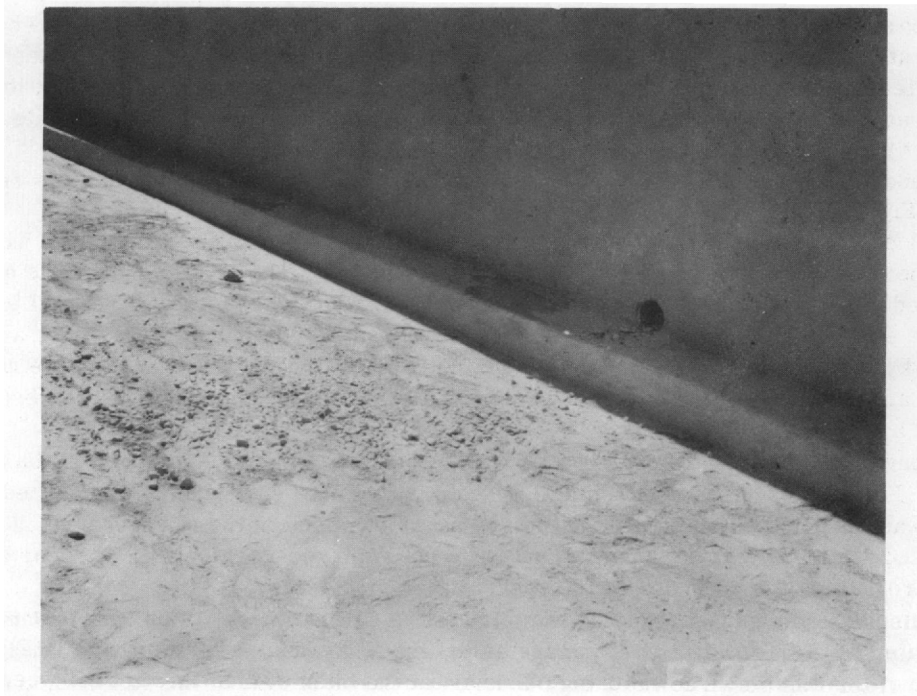
Fig. 3.3—Gravel backfill at weepers (postshot).

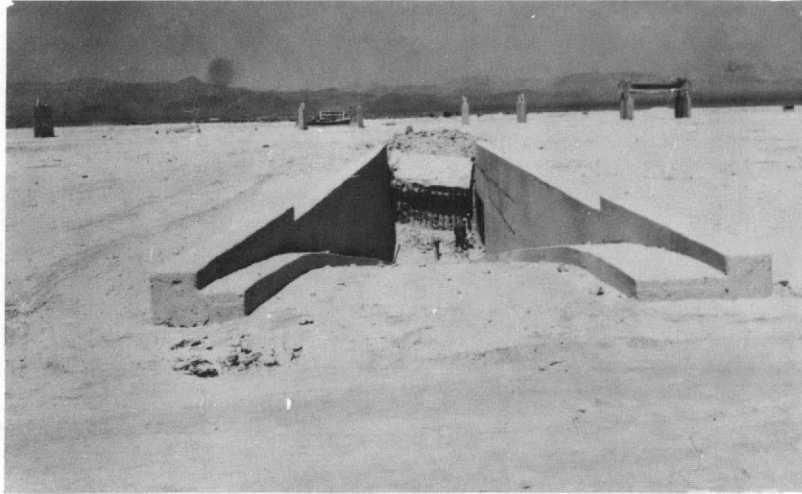
The end wall of the ramp was the only area badly damaged (Figs. 3.4 and 3.5). The top 8 ft of the end wall was broken off as a single unit on a nearly horizontal plane at the top of the splice of the vertical steel. It tipped into the backfill and slipped over the lower section until it wedged tightly between the garage wall and the longitudinal wall of the ramp. It was torn

Fig. 3.4—View of ramp looking toward damaged end wall (postshot).

The only substantial damage noted in connection with this project was to the retaining wall at the end of the ramp where damage was expected (see Sec. 1.4). The peak average pressure on the end wall was 188 psi (110 psi at the top and 266 psi at the base), considerably higher than the peak free-field side-on pressure of 39 to 40 psi recorded at the ground surface. This was due mainly to reflections and the added effect of the dynamic pressures, which were much higher than the side-on pressures at this range. The dynamic-pressure gauge at the base of the ramp was packed with debris and did not record. However, the dynamic-pressure gauge at the surface did record a peak dynamic pressure (corrected) of 112 psi. A peak pressure of 105 psi was recorded on the door (12 ft from the end wall), and the electronic side-on gauge (25 ft from the end wall) recorded a peak pressure of 54 psi. These gauge records are of appreciable significance; however, gauge P4 had a faulty connection and, as a consequence, the pressure back-up in the ramp was not fully defined. Blast results were not successfully recorded by the Carlson gauges behind the ramp retaining walls or the deflection gauges on these walls.

There is evidence that at the time of detonation the upper several feet of backfill behind the end wall was not compacted in accordance with the specifications because of excavation and backfilling for an instrumentation cable trench after original backfilling had been completed. Such a condition would mean that greater deflection would be required before the maximum passive resistance of the soil was developed. Although the damage to the end wall is not important in connection with this project, the mode of failure is technically interesting. Because of its orientation and high pressure loading, the wall was expected to deflect into the backfill by yielding of the reinforcement; however, the concrete and reinforcement were expected to remain bonded together, although the concrete would be badly cracked. The complete separation of the top half of the end wall from the bottom, disintegration of the lower portion into loose rubble, separations along the planes of the reinforcement, and failure of the splices without yielding of the steel can be partially attributed to the poor adhesive quality of the concrete in place. However, the mode of failure also may have been influenced by the rapid blast loading and the probability that the strength of normal splices under such loading may be much lower than under static loading. Laboratory data to verify splice efficiencies under dynamic loading would be highly desirable. The ductility of the wall would be greatly increased by raising the splice point, welding the splices, using full-length bars (thus eliminating the splice), and by providing a vertical expansion joint at the intersection with the longitudinal wall. High door pressures would have been avoided if the ramp had been of a symmetrical through type without an end wall. However, a through type ramp, although desirable to minimize blast effects, is often not economical or practical.

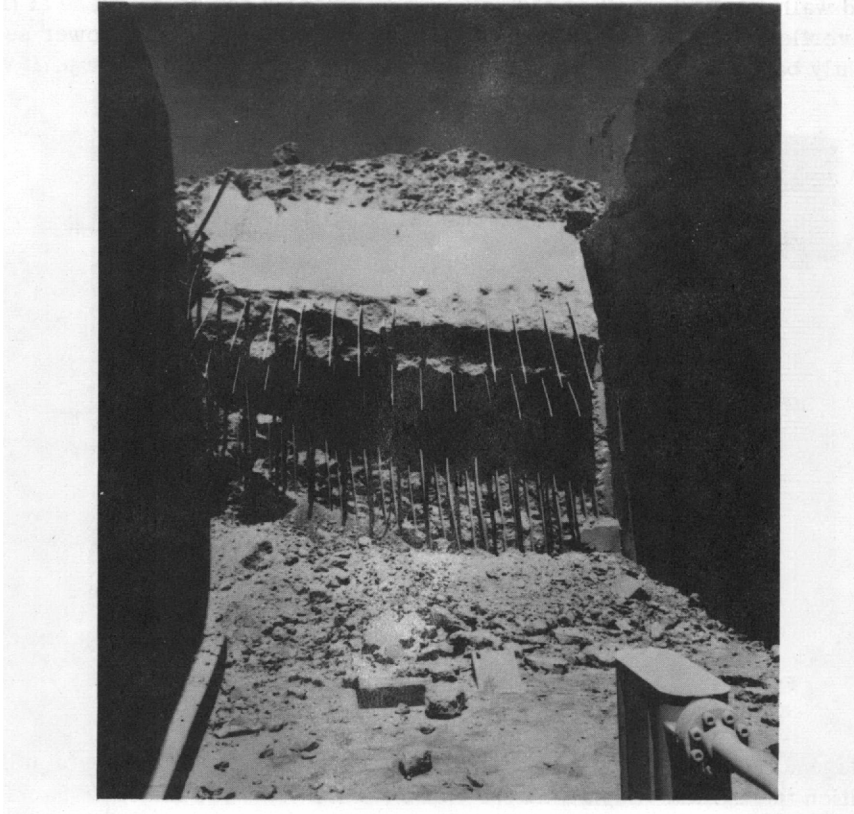
loose on a diagonal through the corner at its junction with the longitudinal retaining wall. In its final position the top was displaced approximately 5 ft 6 in. into the earth backfill, which was pushed up and mounded. It was estimated that it may have been displaced approximately 8 ft before sliding back. The concrete cover had split off most of the lower section, and the bars had separated at the splice, apparently without having developed their yield strength. Near the middle of the panel where the concrete had not split, three bars had fractured after necking down at the top of the splice (Fig. 3.6).

The end corner of the 1-ft 3-in. parapet wall at the lower end of the ramp was cracked as shown in Fig. 3.5.

Fig. 3.5— Close-up of damaged end wall (postshot).

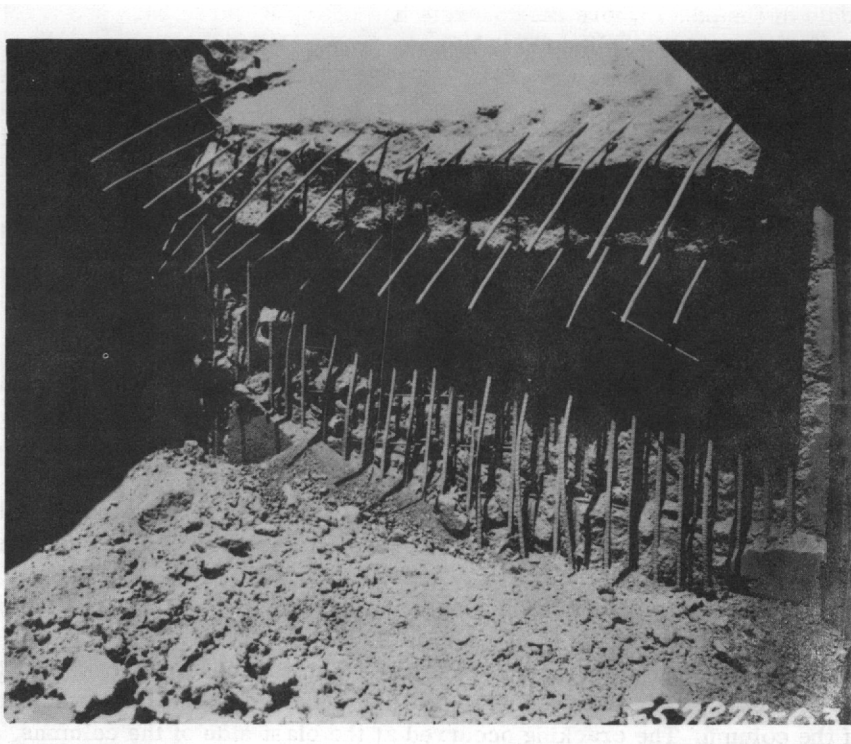
Fig. 3.6— Detail of failure showing fractured bars (postshot).

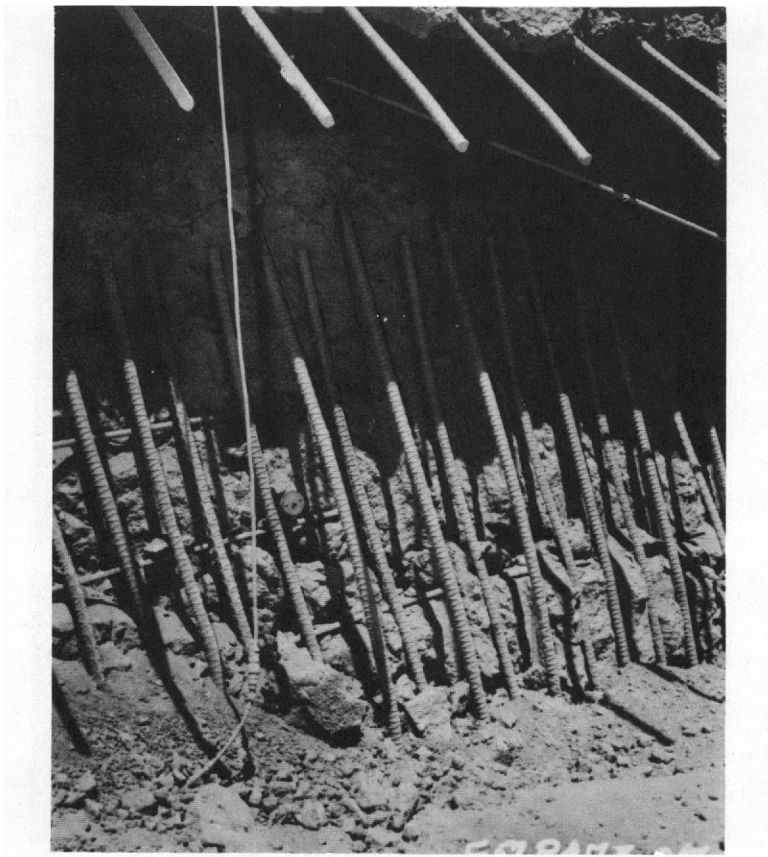
The bars in the lower section were bent away from the displaced concrete; the cover was deposited at the base (Fig. 3.7). The remaining concrete behind the bars was reduced to rubble, which varied in size from 6 in. to 3 ft in diameter. Fractures, including the one at the bottom of the top section of the damaged end wall, revealed no breaks through the aggregate. The concrete had also separated on the plane of the rear-face reinforcement.

Fig. 3.7—Detail of lower portion of wall (postshot).

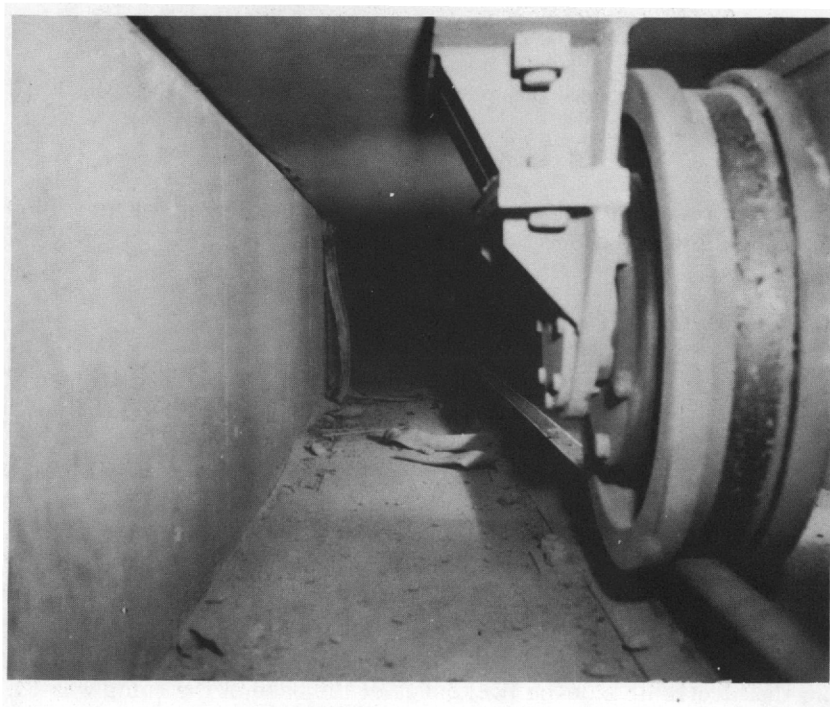
The door withstood the blast without any evidence of shifting or disalignment. Locking bolts in the door were intact and retracted freely (Fig. 3.8). The  $\frac{1}{4}$ -in. cover-plate angle at the exposed top edge of the door frame was separated from the concrete at several locations. The 12-in. steel guide plate on the 4.5-ft wall was not made continuous as intended and was torn back by the door during the postshot opening (Fig. 3.9). The door wheels were not damaged, and the track was not displaced (Fig. 3.10). The door and end pilaster were partially blackened by thermal radiation.

Fig. 3.10—Wheel assembly and rails, door partly open (postshot).

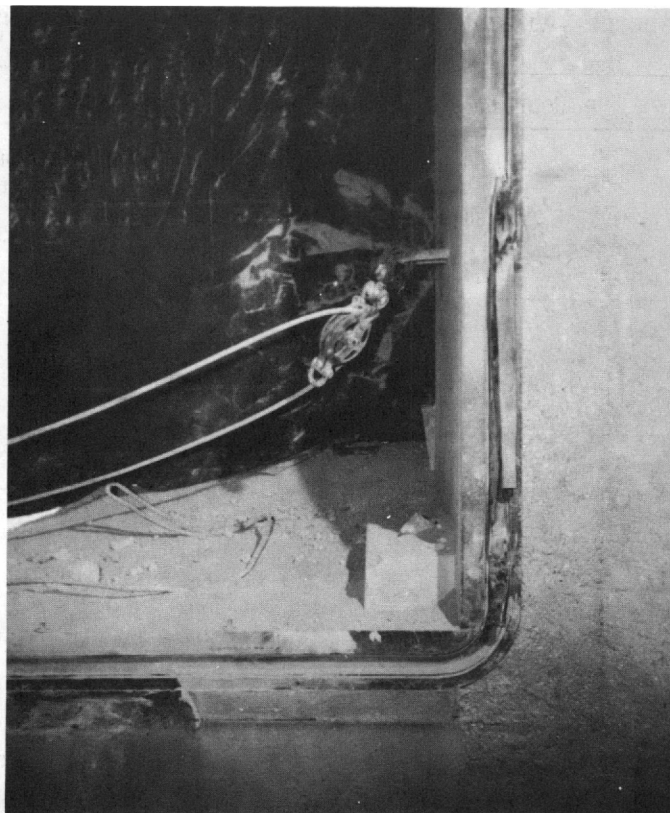
The pneumatic gasket around the door frame was blown in and torn apart by the blast pressure (Fig. 3.11). The gasket had a slow leak prior to the shot, and a compressed-air cylinder was installed outside in the doorway recess to maintain the air pressure. The cylinder and air hose were sandbagged and were not damaged by the blast. No information is available regarding the condition of the gasket at shot time.

Fig. 3.11 — Damaged gasket at lower corner of door opening (postshot).

The as-built clearances between the door and frame were as high as  $\frac{13}{16}$  in., more than three times that shown on the plans; therefore the pneumatic seal would have been ineffective even in good working condition. To prevent excessive infiltration of the blast pressures, clearances at the base were reduced prior to the shot by 3- by 3- by  $\frac{3}{8}$ -in. angles; one leg was inserted vertically into the opening, and the other was bolted to the frame. The blast pressures still entered the joint and forced the gasket toward the interior of the shelter, stripping and tearing it along its entire length. It is not known whether or not the compressed-air cylinder placed prior to the test was adequate to maintain pressure in the gasket up to shot time.

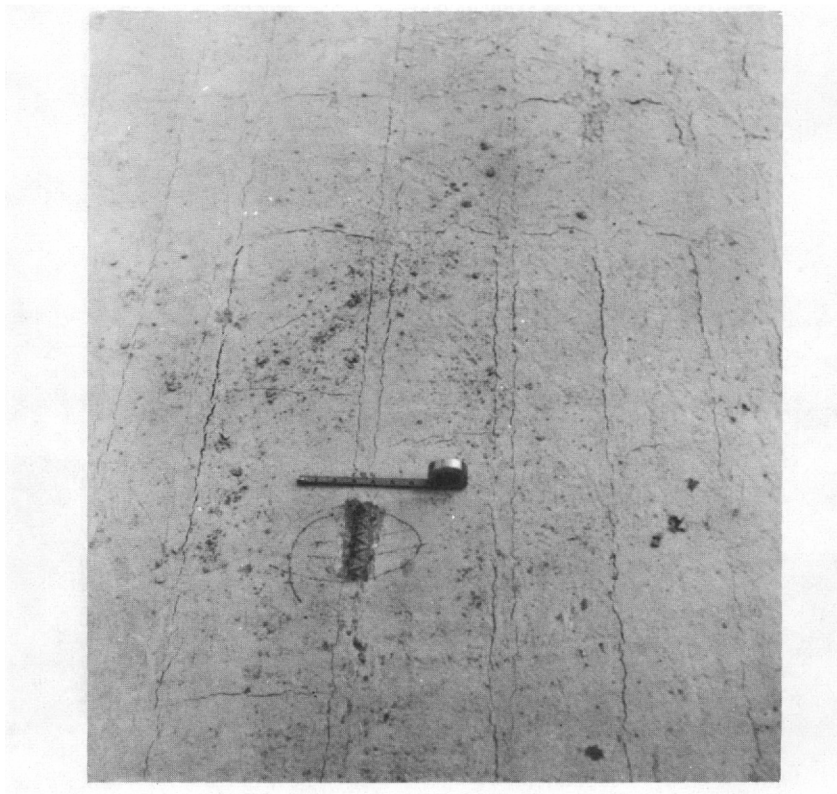
**Fig. B.29—Shrinkage cracks in roof-slab concrete.**

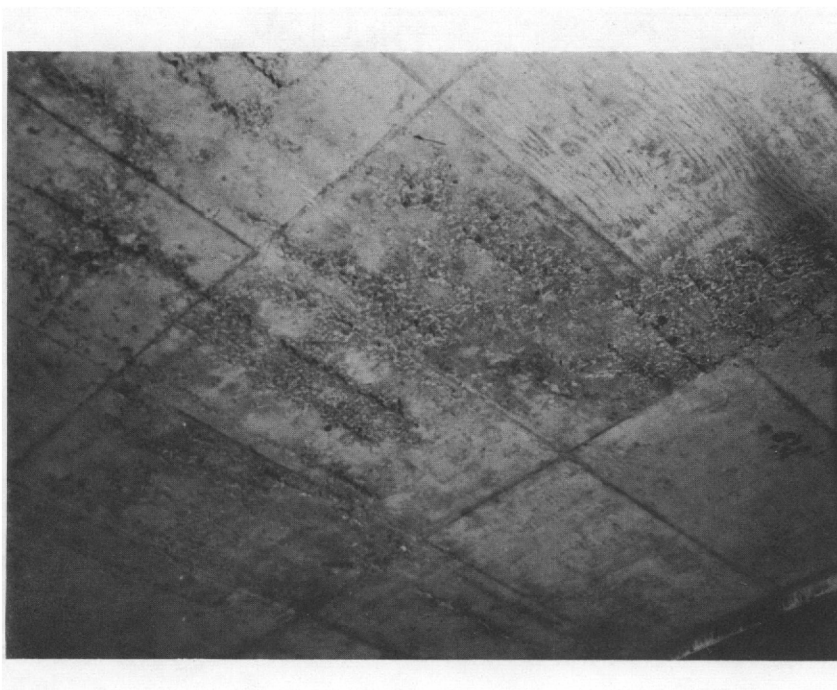
**Fig. B.30—Honeycombed area on underside of roof slab.**
